Dalvegur

Reflex Arkitekter

PG-Verk

7 November 2022

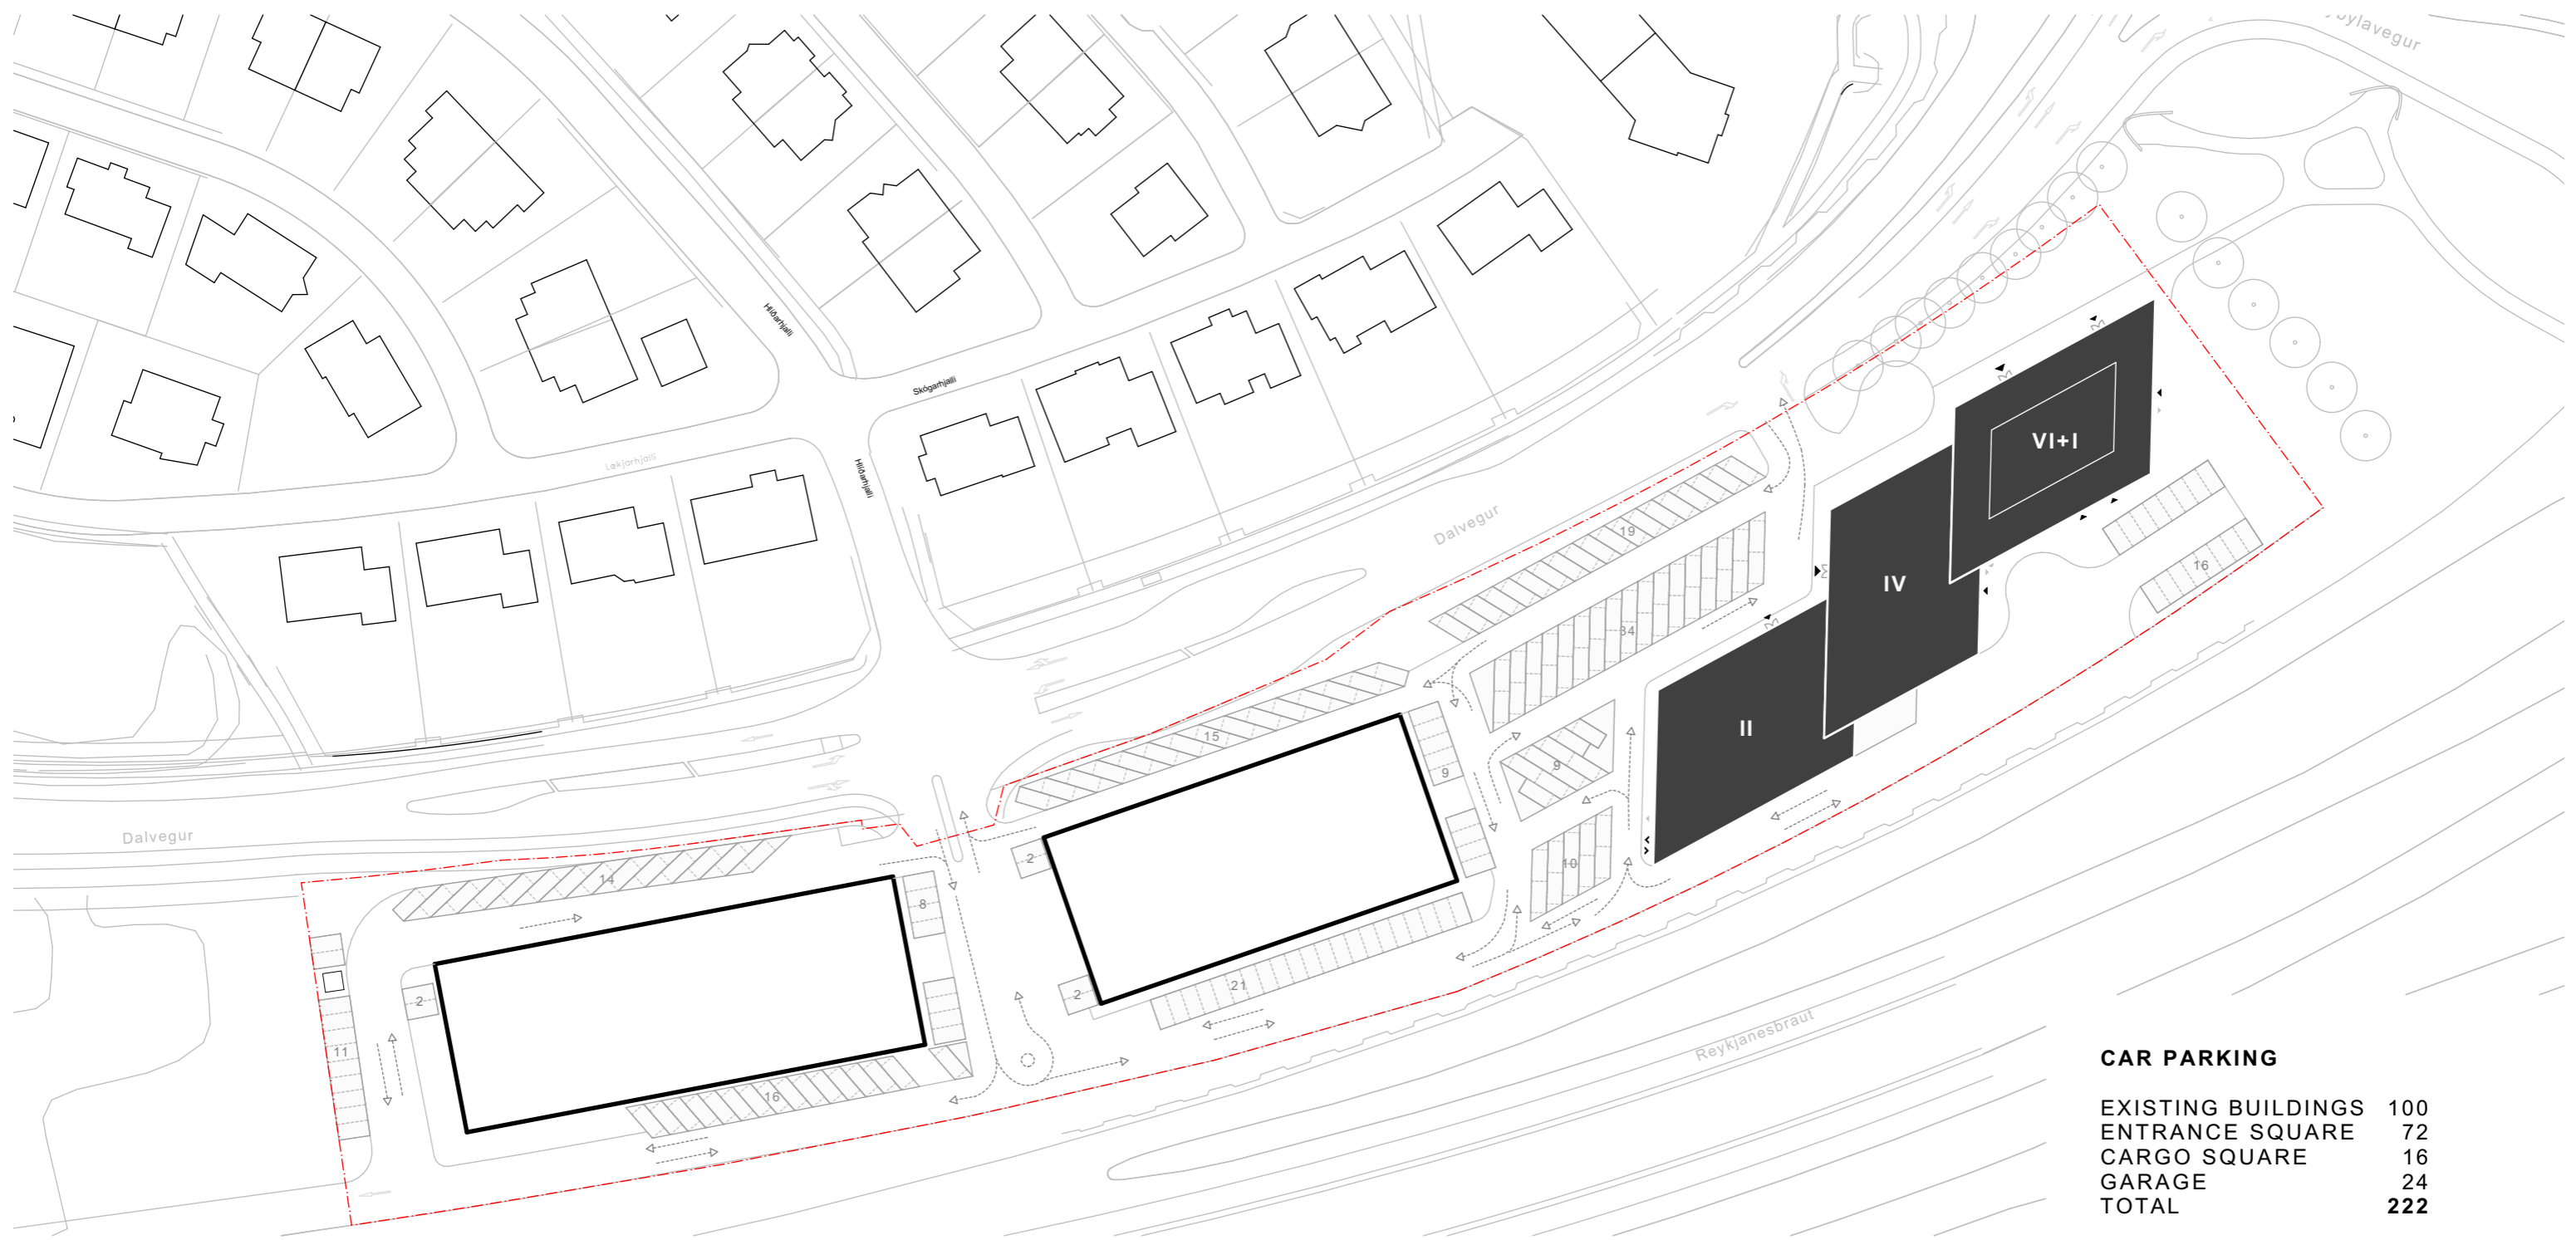
CAR PARKING

EXISTING BUILDINGS	100
ENTRANCE SQUARE	72
CARGO SQUARE	16
GARAGE	24
TOTAL	222

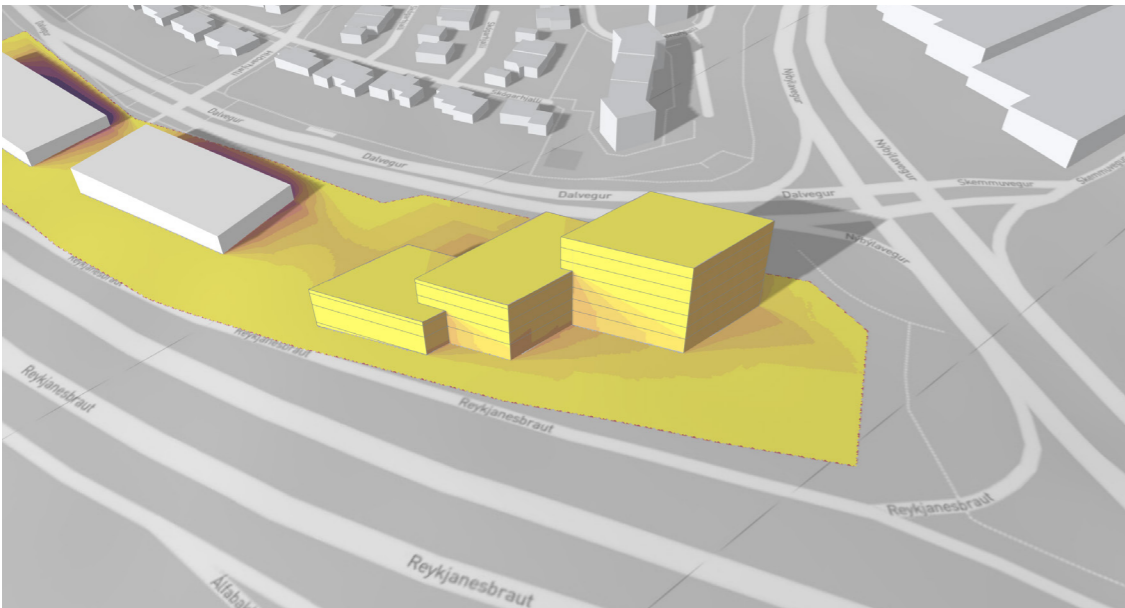
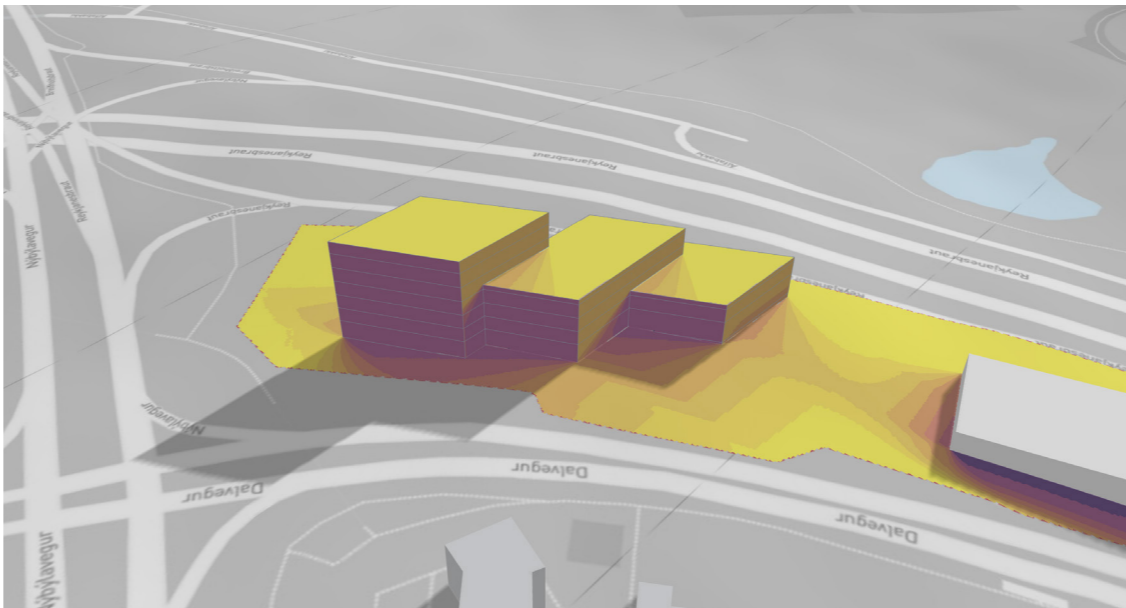
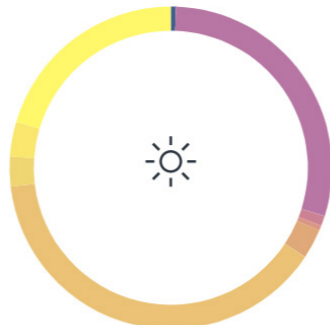
March 21

Solar analysis

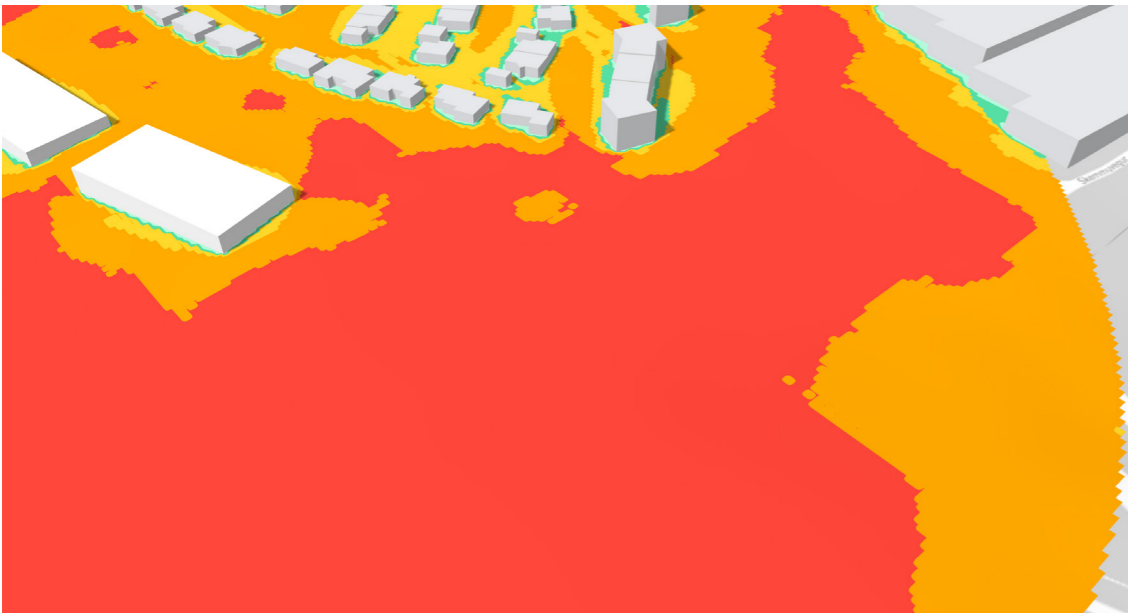
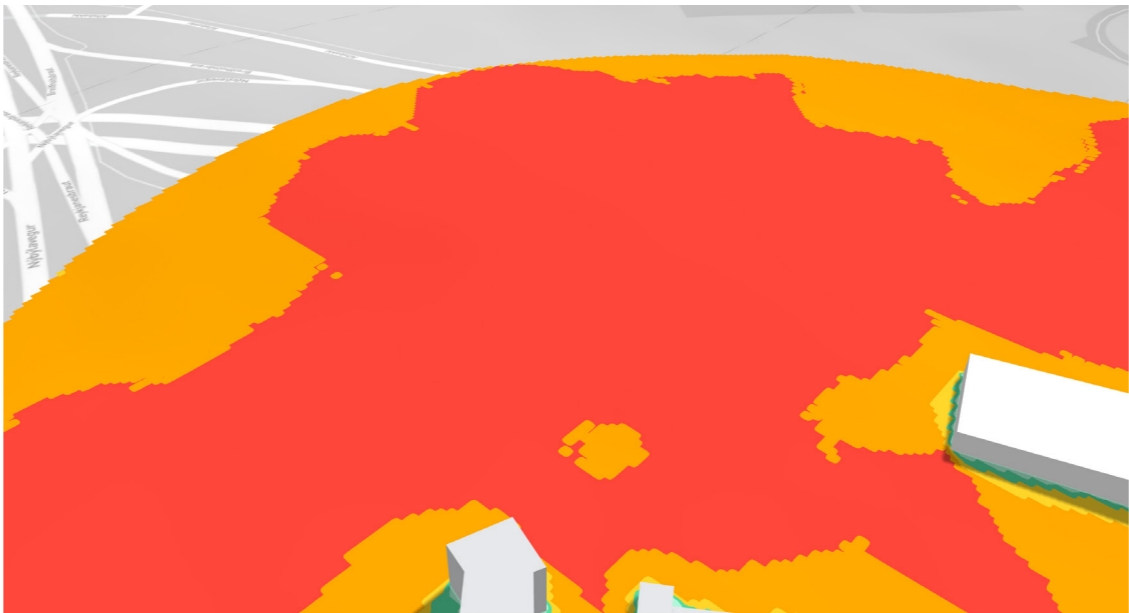
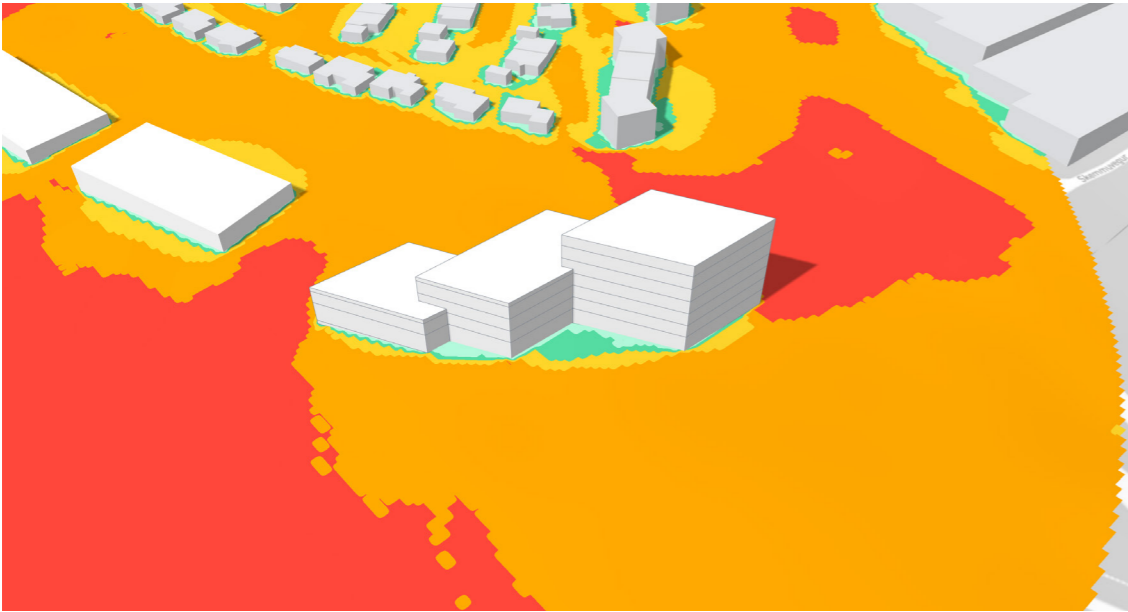
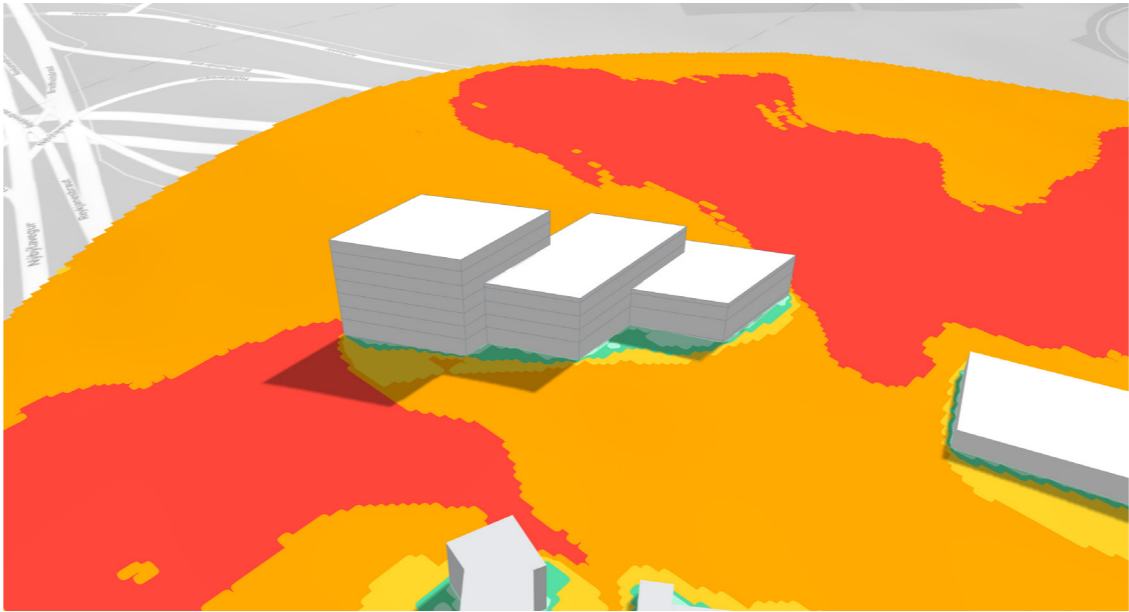
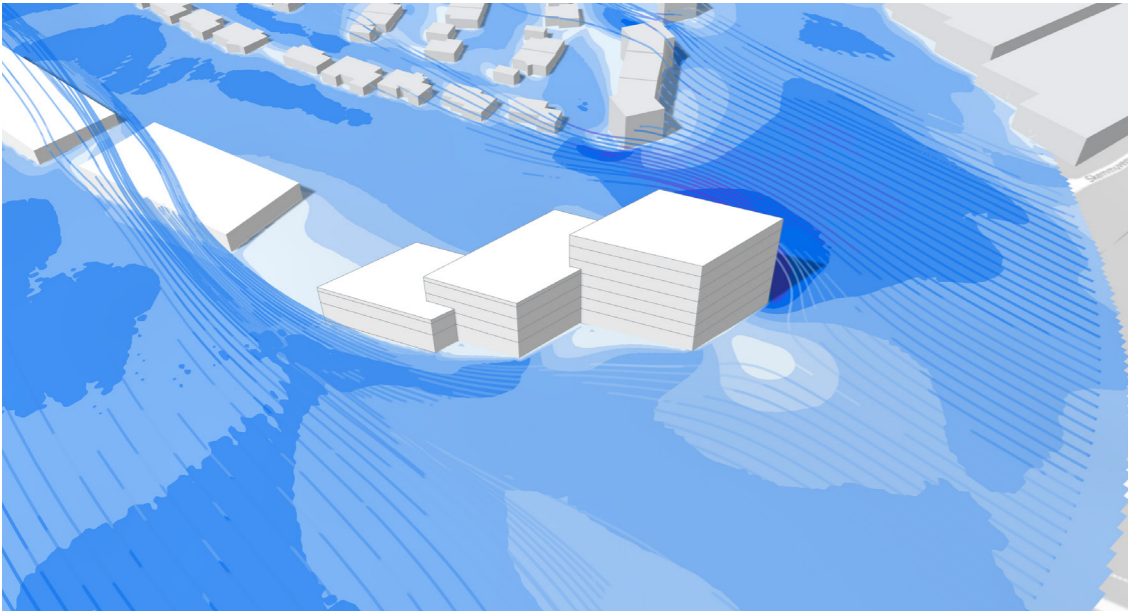
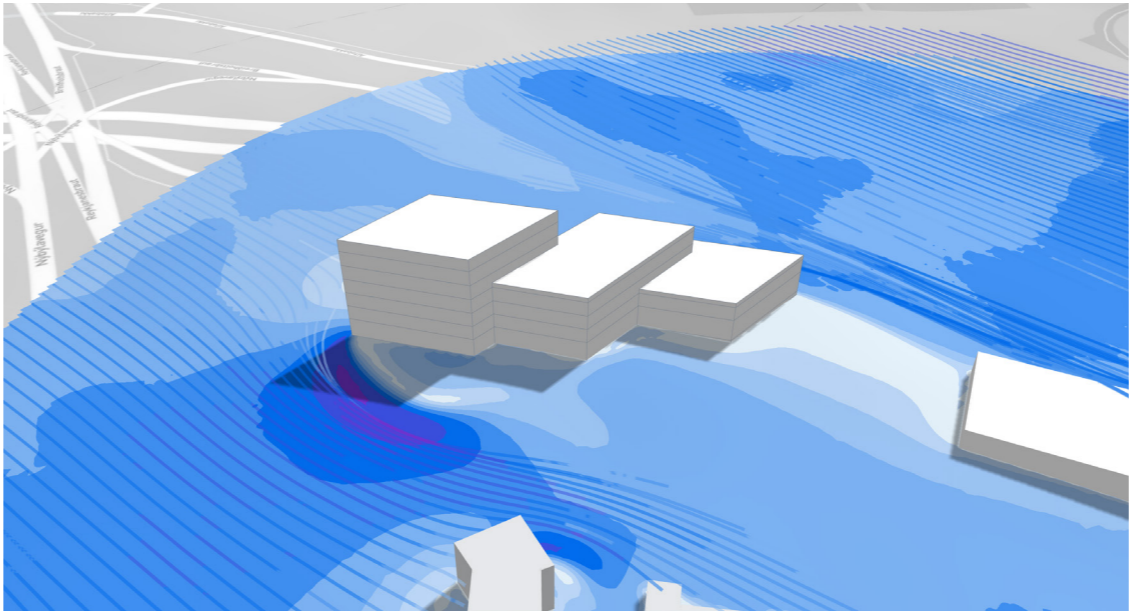
Wind analysis

Existing situation

Future situation

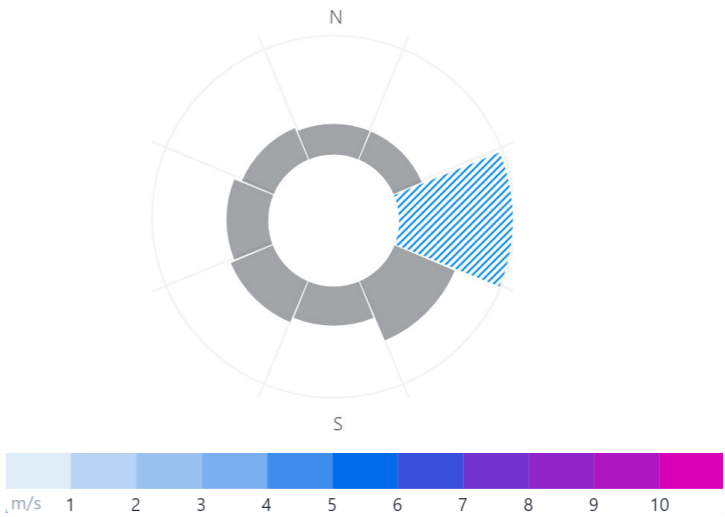
Most common wind direction

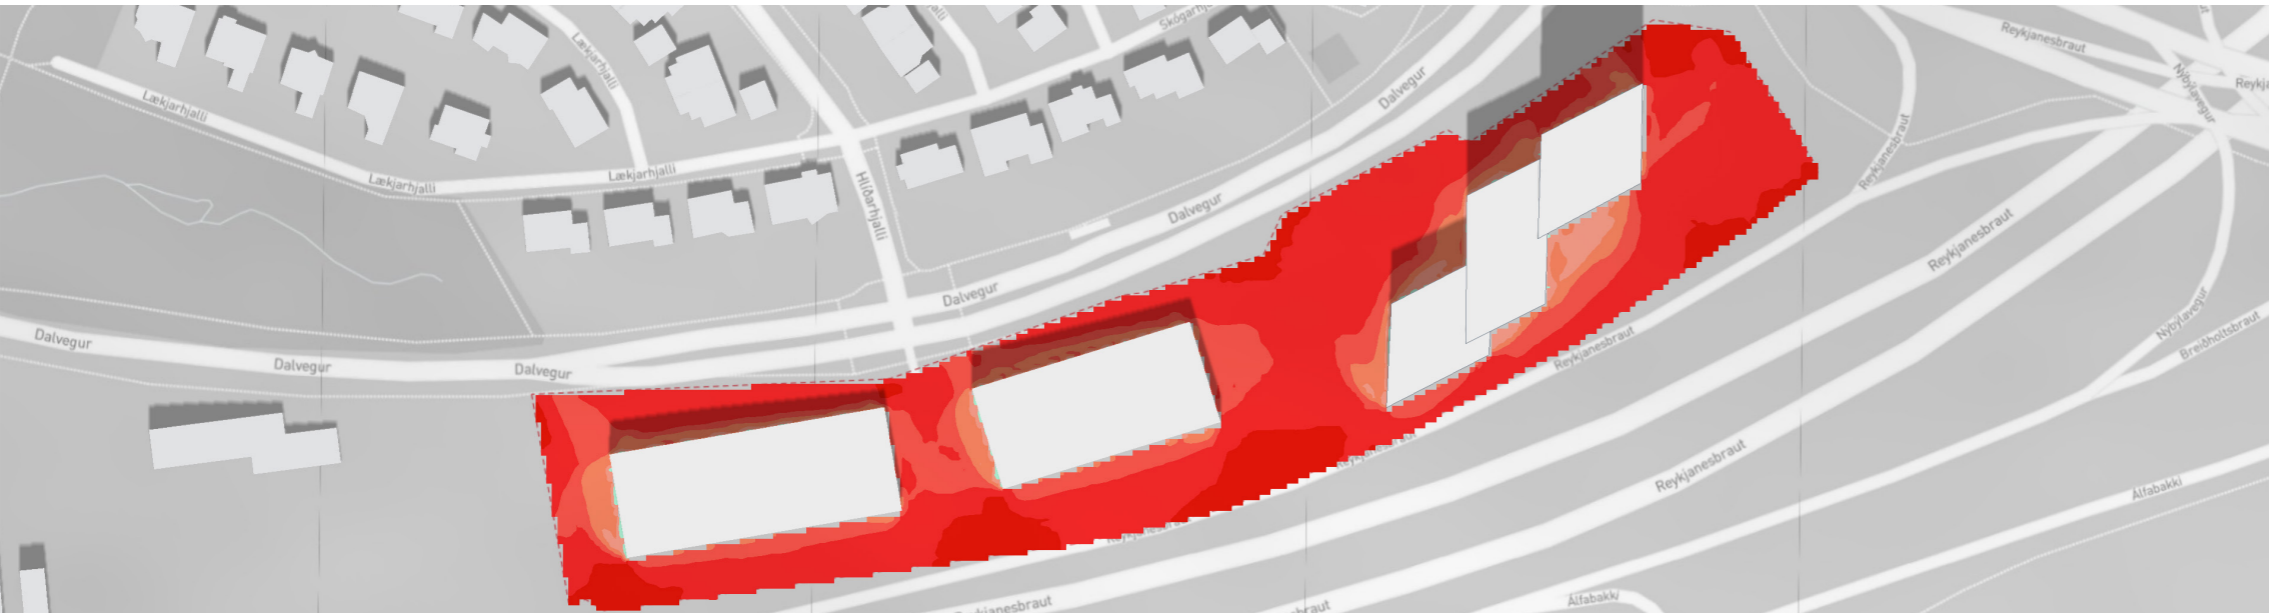
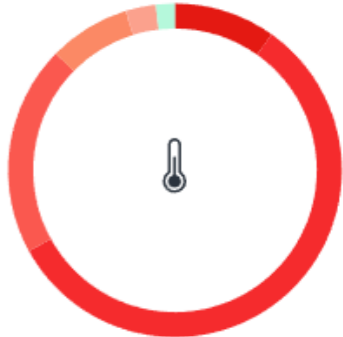
April 21

Climate comfort analysis

98 %
2 %

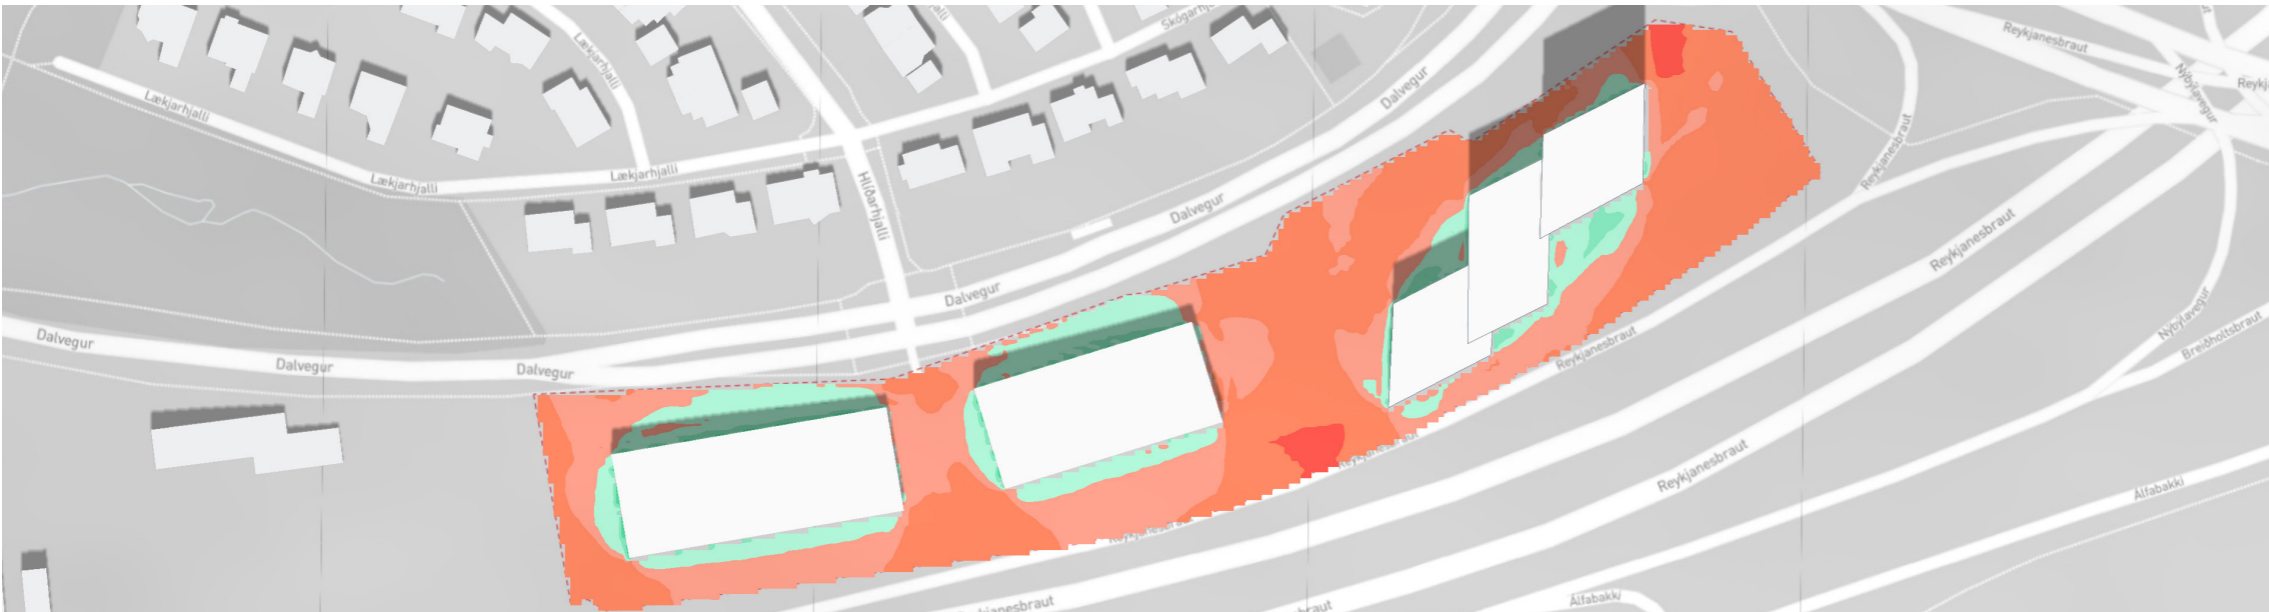
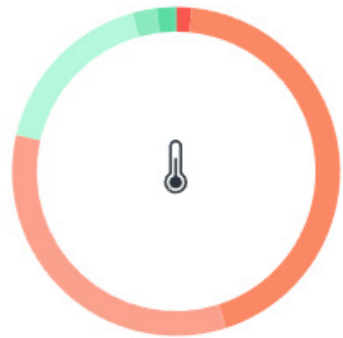
May 21

79 %
21 %

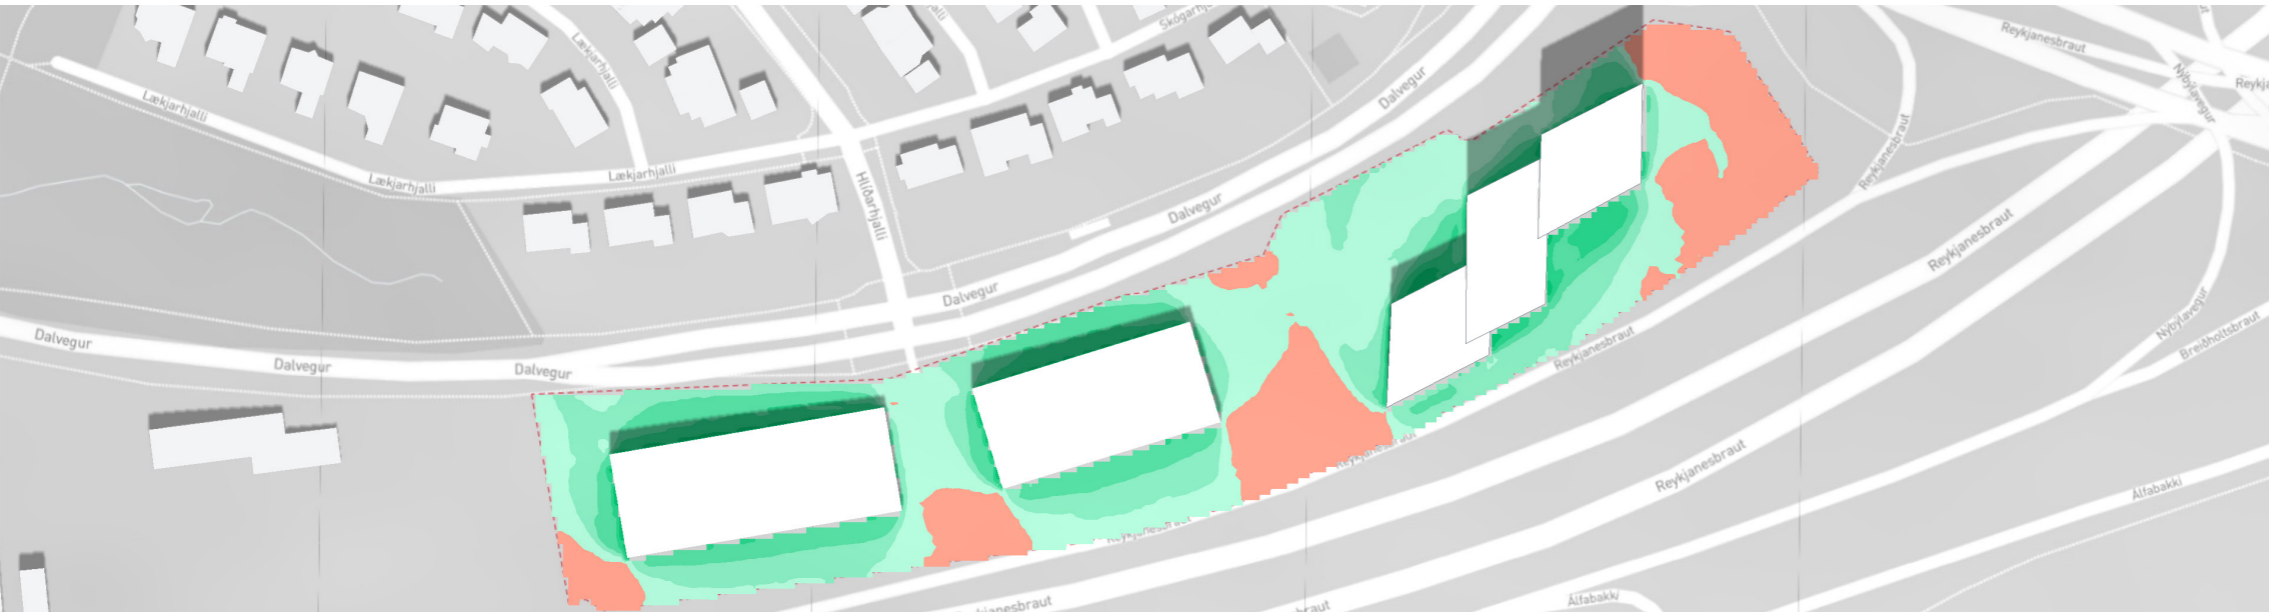
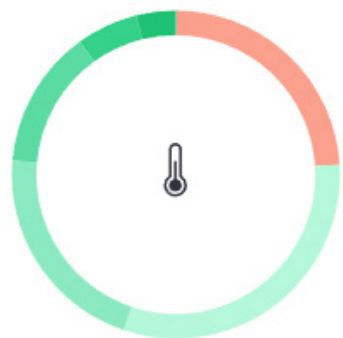
June 21

24 %
76 %
